The Rebirth of Tower 473N

The inhabitants of Putumayo were on the verge of a blackout following a landslide that affected an electric power transmission tower. A GEB team, in the midst of difficult conditions and in record time, built a new tower, code-named 473N.

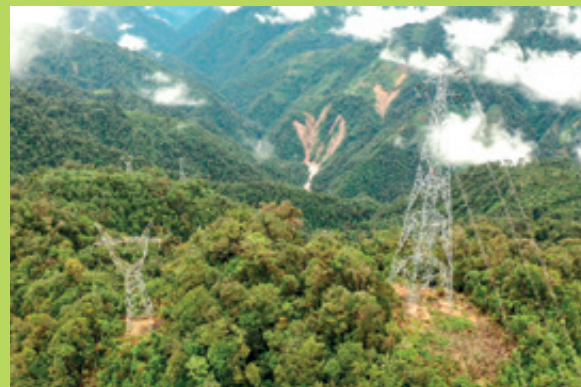
After a lot of hard work, the tower was raised, which enables the transportation of electric energy to southern Colombia

At the same time, we carried out the technical and engineering studies for the final solution on the Teja line and for the controlled dismantling of tower 472. It was to be implemented by March 10, 2019 at the latest. The best option was to remove tower 472 from the line and instead build a new 70-meter structure, called tower 473N.

To win the battle against time, we used the existing head of tower 473 and built the rest. In mid-February we disassembled towers 472 and 473. It was a very complex operation because our employees had to be ready at the meeting place in Mocoa at four o'clock in the morning to undertake a four-hour walk to the work site. "We refurbished six kilometers of that difficult dirt trail and used mules and motorcycles with small platforms to transport some materials. The vehicle could only go so far, and from that point on, we had to walk", Aponte recalls.

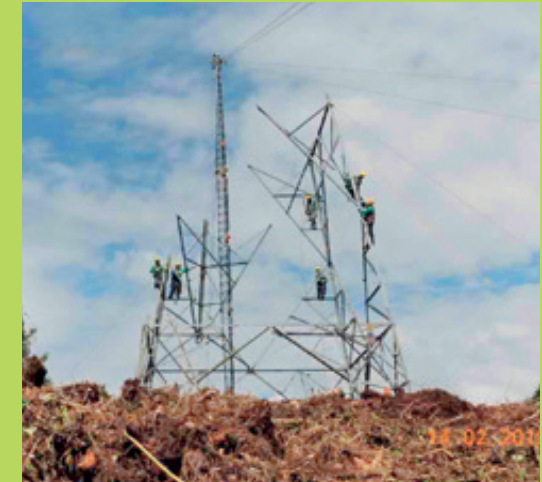
Construction work of tower 309, second section of the Tesalia - Alférez project in Pradera, Valle del Cauca
